Examining the Degradation of Depleted Uranium Layered Hohlräume

A. Schwartz, S. Bhandarkar, M. Havre, L. Ahaian, C. Aracne-Ruddle, A. Nikroo, S. Kucheyev, C. Horwood

¹Lawrence Livermore National Laboratory (LLNL), ²General Atomics

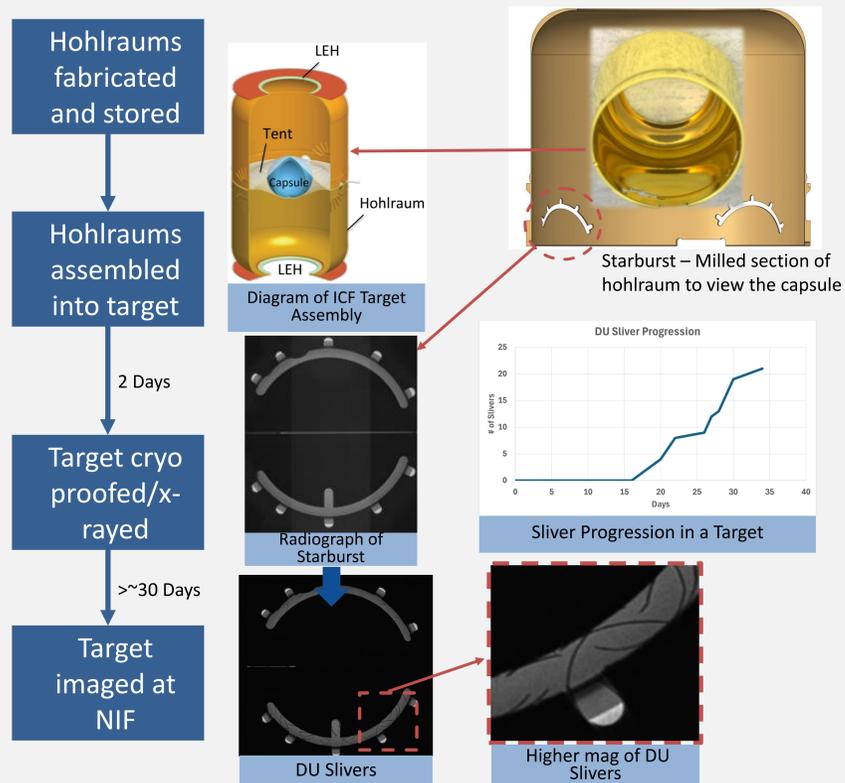
New Mode of Failure – Hohlraum Starburst Degrades Over Time

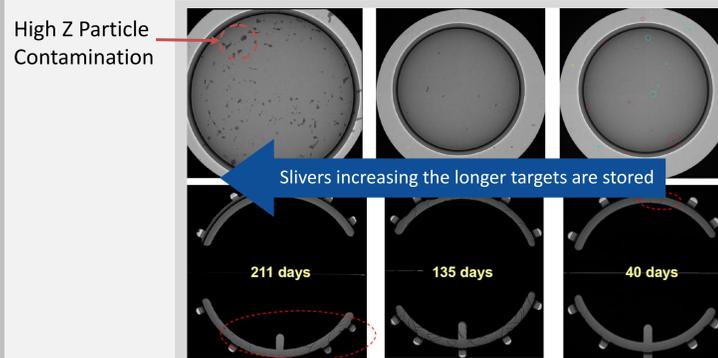
Slivers Can Cause High Z Particle Contamination on Capsule

- Mostly form in the starburst, sometimes in the waistband and never in the LEH
- Slivers are always curved

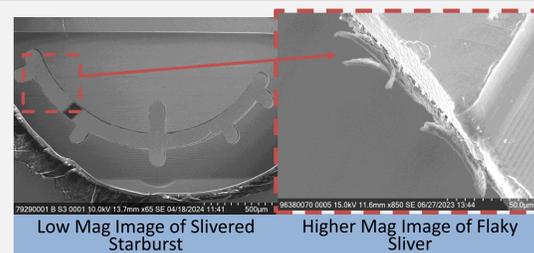
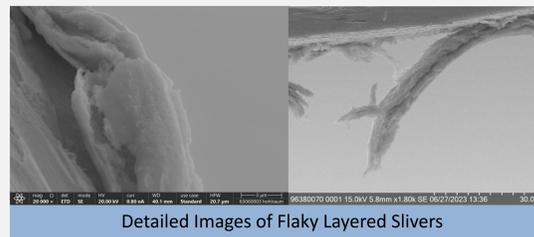
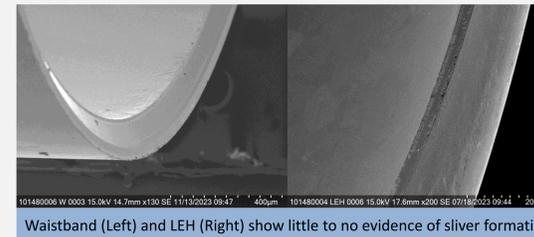
Surface Oxide Layer was Hypothesized to Cause Slivers

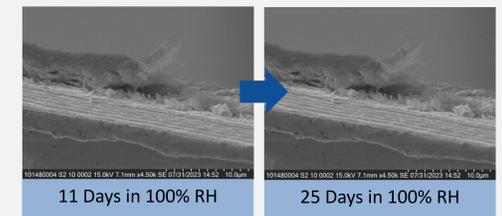
Effect of Moisture on DU Hohlräume Based on Common Cause Mentioned in Literature

- Moisture is known to be an aggravating factor for corrosion layer of DU
- Stored hohlraums in various conditions in attempt to recreate slivers
 - 100% relative humidity (RH)
 - Dry nitrogen
 - Ambient air
- Unable to recreate slivers or cause existing slivers to flake off

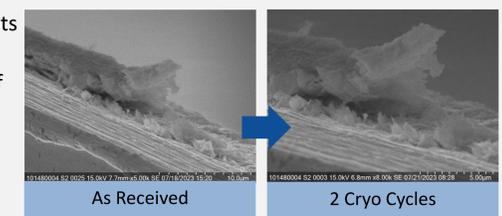
Effect of Cryogenic Cycling Based on Thermal Stress Arguments

- Target is in cryogenic state before shots
- Tested flaky hohlraums through cryogenic cycles to see if flakes fall off due to difference CTE
- No changes to the DU 2 cryo cycles

Cryo cycling does not affect DU corrosion

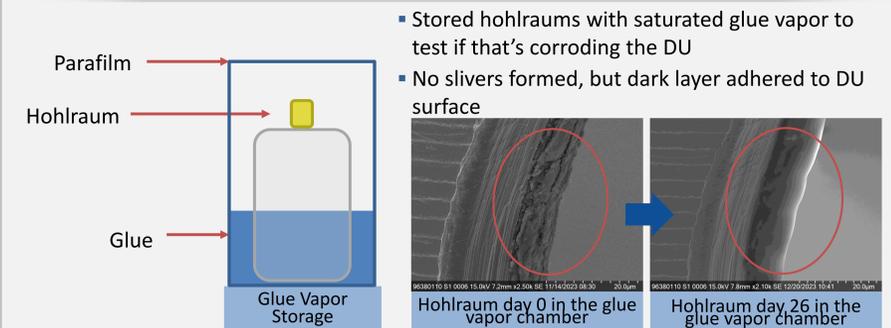
Effect of Glue Vapors Based on Sliver Growth Acceleration Inside Target

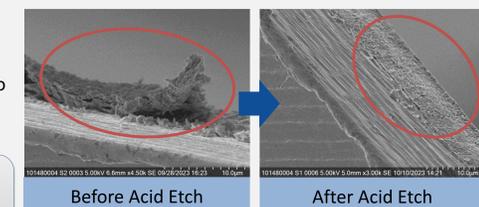
Acid Etching Removes the Flaky Early-Stage Sliver Layer

- Nitric acid etching removes flaky corroded layer quickly
- Dipped hohlraum in acid with custom design basket
- Use acid for 3 hohlraums then dispose it
- Low concentration acid to minimize damage to the metallic DU layer
