Examining the Degradation of Depleted Uranium Layered Hohlräume

A. Schwartz, S. Bhandarkar, M. Havre, L. Ahaian, C. Aracne-Ruddle, A. Nikroo, S. Kucheyev, C. Horwood

¹Lawrence Livermore National Laboratory (LLNL), ²General Atomics

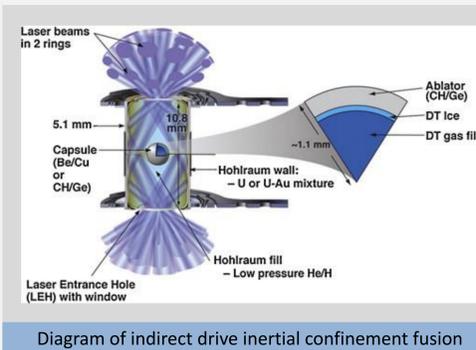
Particles on capsule made of high atomic number (High Z) are unacceptable

- Hohlraums are used for indirect drive inertial confinement fusion
- Hohlraums are made up of layered DU-Au and are in close proximity to the capsule
 - If hohlraum sheds particles it goes onto the capsule, affecting the implosion symmetry
- Over the last year, several targets have failed due hohlraum failures
